The Significance of Defects in CFRP Bonded Honeycomb Structures
and Non-Destructive Test Methods for Their Destruction

(FRI-R736/4) THE SIGNIFICANCE OF DEFECTS IN
CFRP BONDED HONEYCOMB STRUCTURES AND
NON-DESTRUCTIVE TEST METHODS FOR THEIR
DETECTION Final Report (Fulmer Research
Inst. Ltd.) 114 p HC A06/MF A01

EUROPEAN SPACE AGENCY

R736/4/May, 1978

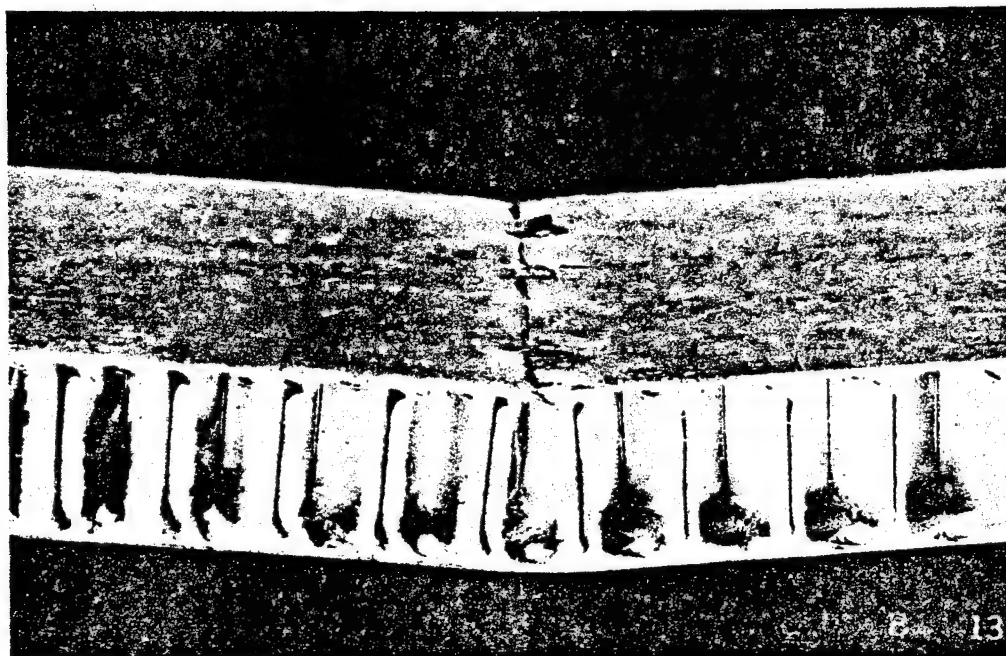
Figure 14 0/90/90/0 flexural test specimen with fibre directions \parallel and \perp to beam axis showing compressive failure of upper face skin and undamaged honeycomb core.
(Specimen 13B)

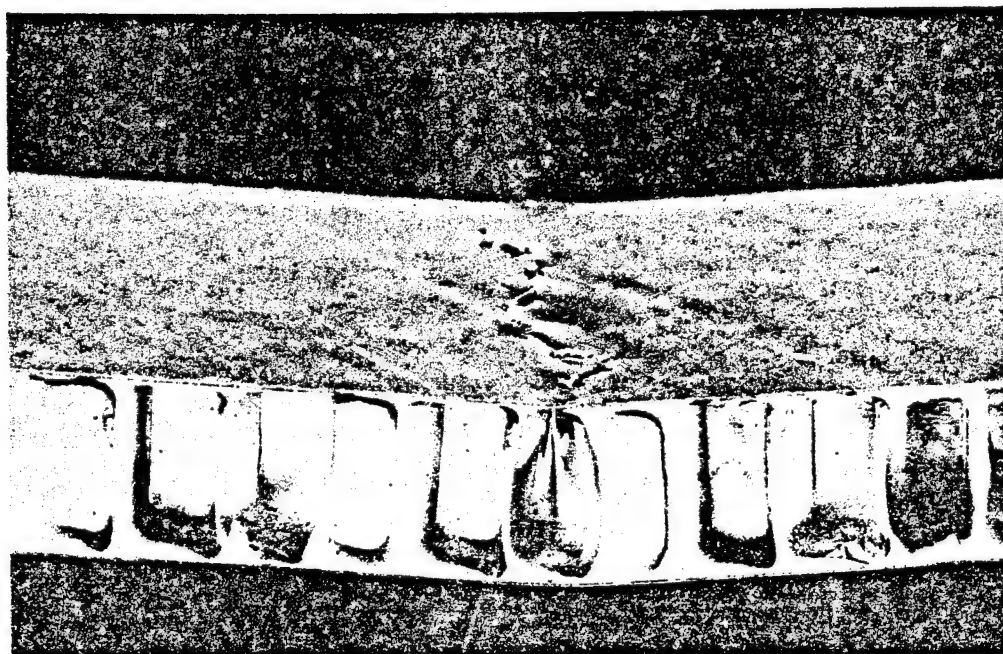
Figure 15 0/90/90/0 flexural test specimen with fibre directions at 45° to beam axis showing compressive failure of upper face skin.

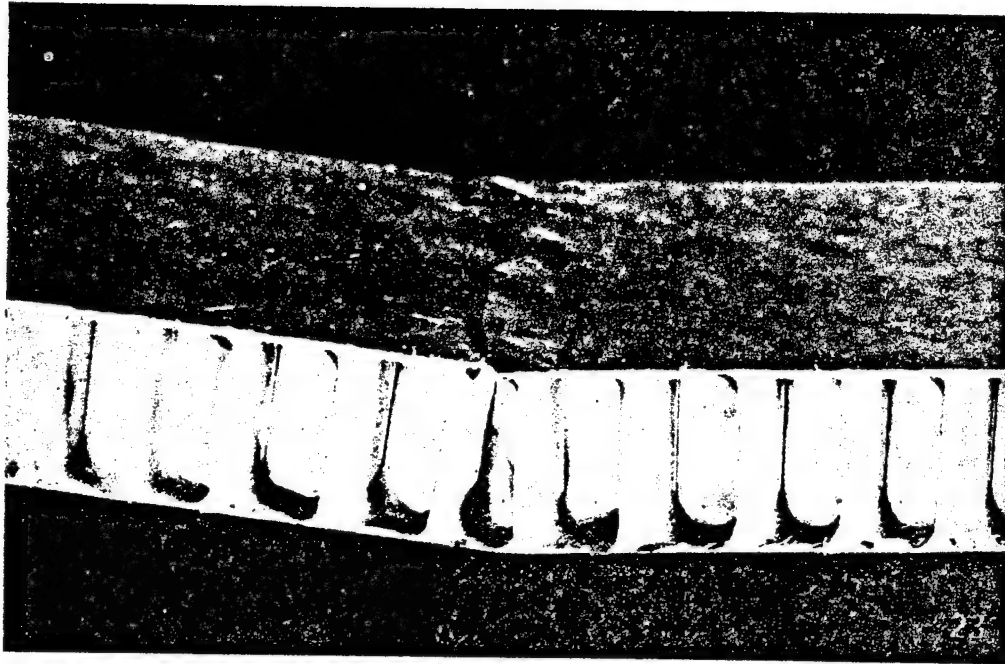
Figure 16 O/60/l20 flexural test specimen showing compressive failure of upper face skin and undamaged honeycomb core.
(Specimen 23C)

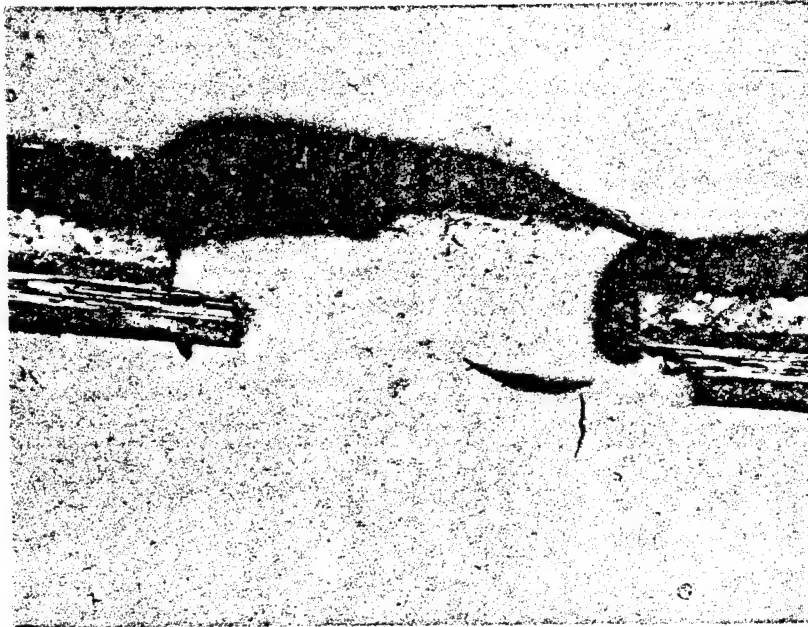
Figure 17 Micrograph of section of fracture area in the face skin showing fracture of both the plies and the adhesive layer.
(Specimen 2B x 50)

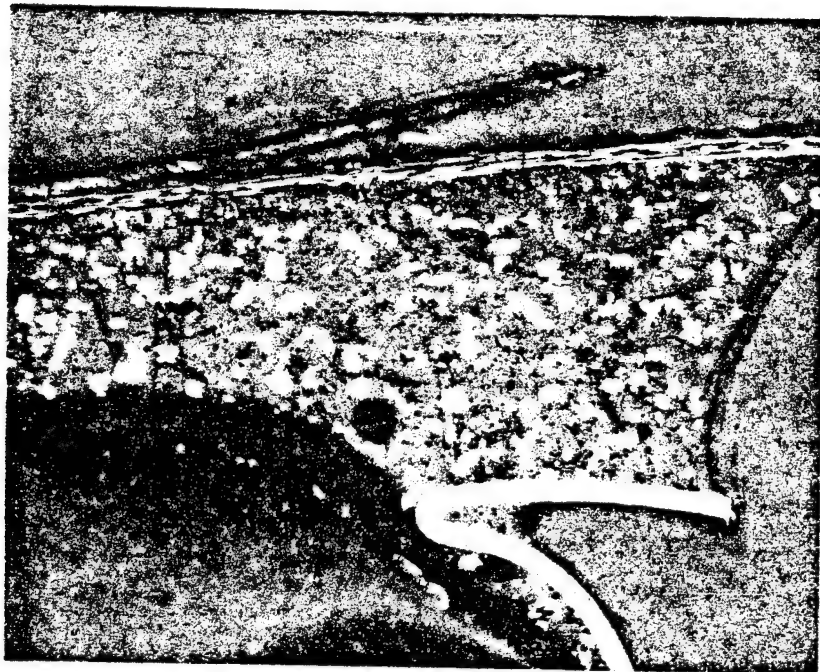
Figure 18 Micrograph of fracture showing delamination of face skin and adhesive and deformation of the honeycomb core.
(Specimen 13C x 50)

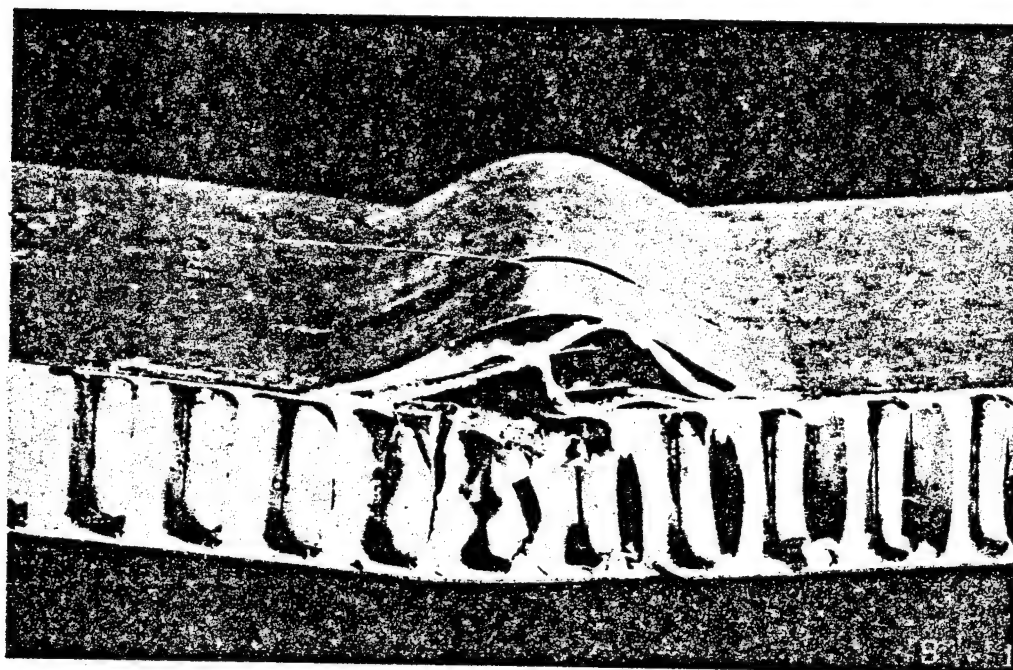
Figure 19 Fractured beam containing a backing sheet contamination defect showing delamination but not fracture of the face skin and local collapse of the honeycomb core.

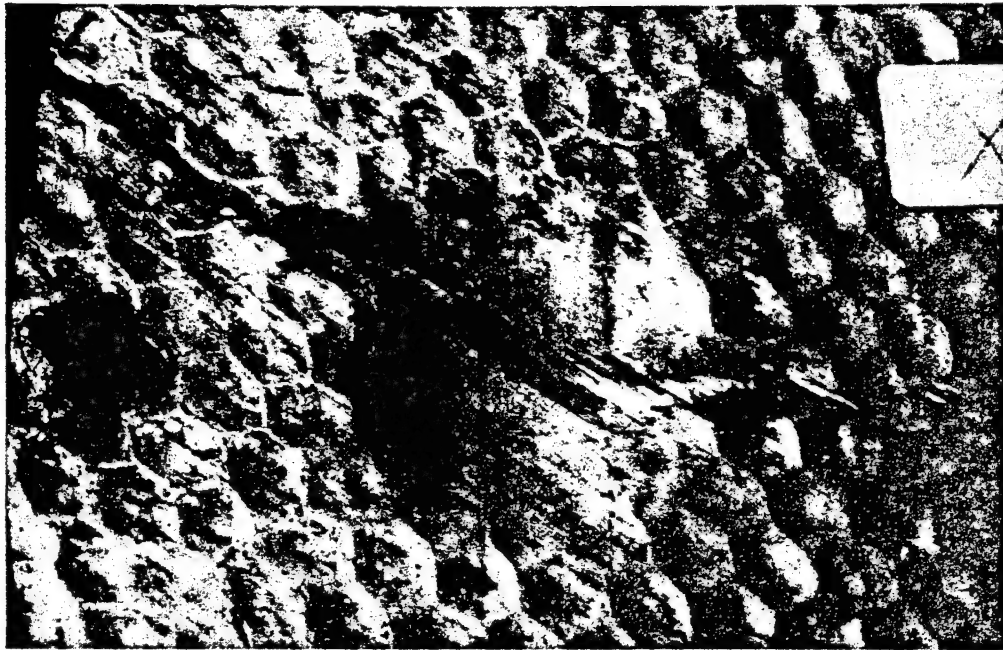
Figure 20 Radial crack passing through a severe defect which resulted in failure of Dish 2.

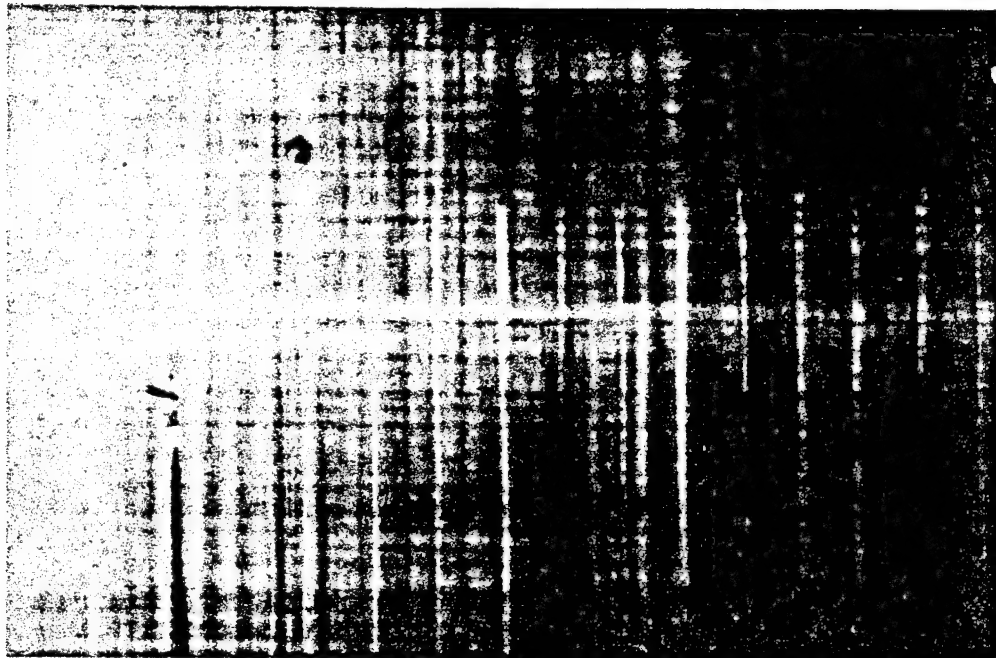
Figure 22 Low energy (7kV) x-radiograph of a 4 ply laminated CFRP skin before bonding to a honeycomb core. The prominent light strips running from the lower edge to three-quarters height are due to prepreg splits, the less pronounced light and dark stripes running vertically and horizontally indicate uneven fibre distribution in the prepreg. (Sections 3.3. and 5.1.4)

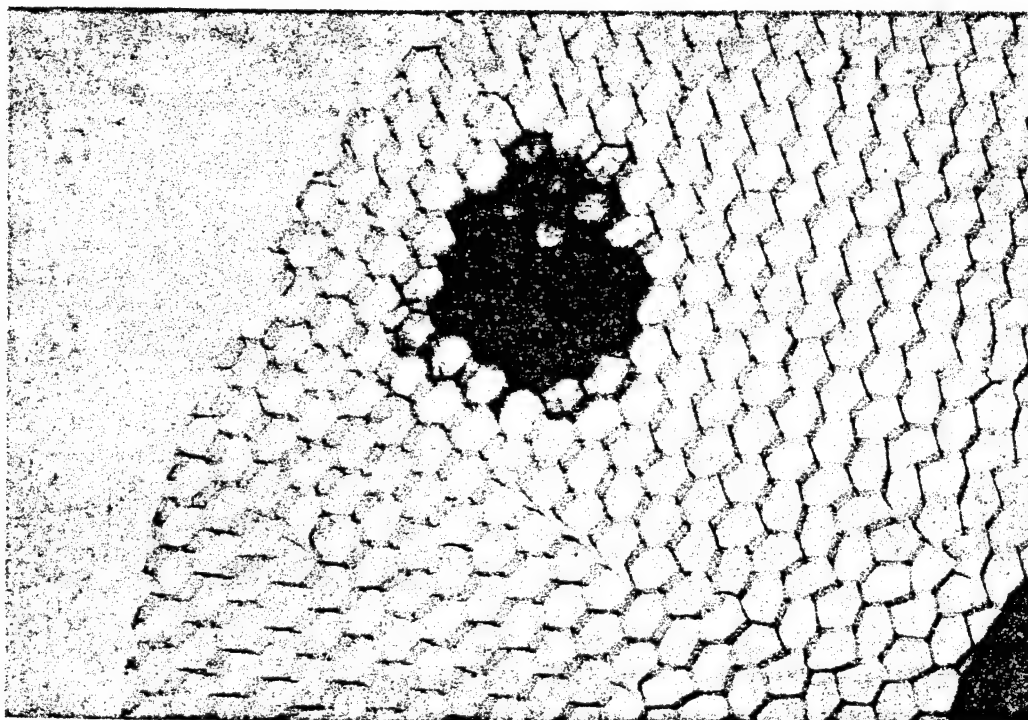
Figure 24 Conventional x-radiograph using a contact technique and 50kV x-rays showing clear visualisation of the aluminium honeycomb and encapsulation compound. Some local damage to the core is seen above the dark area of encapsulation compound. (Section 3.3. & 5.1.4)

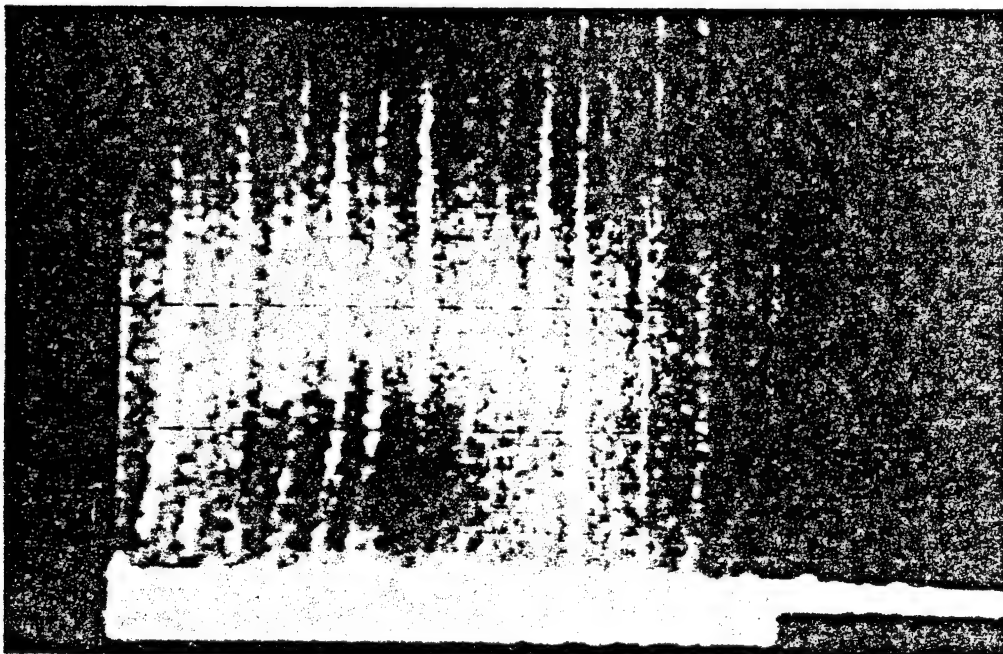
Figure 27 Prepeg gaps and splits revealed by thermography. xlMag. Resolution on screen is better than in photographic reproduction but this figure is representative of the results achieved with this technique. (Sections 3.5 & 5.1.6)

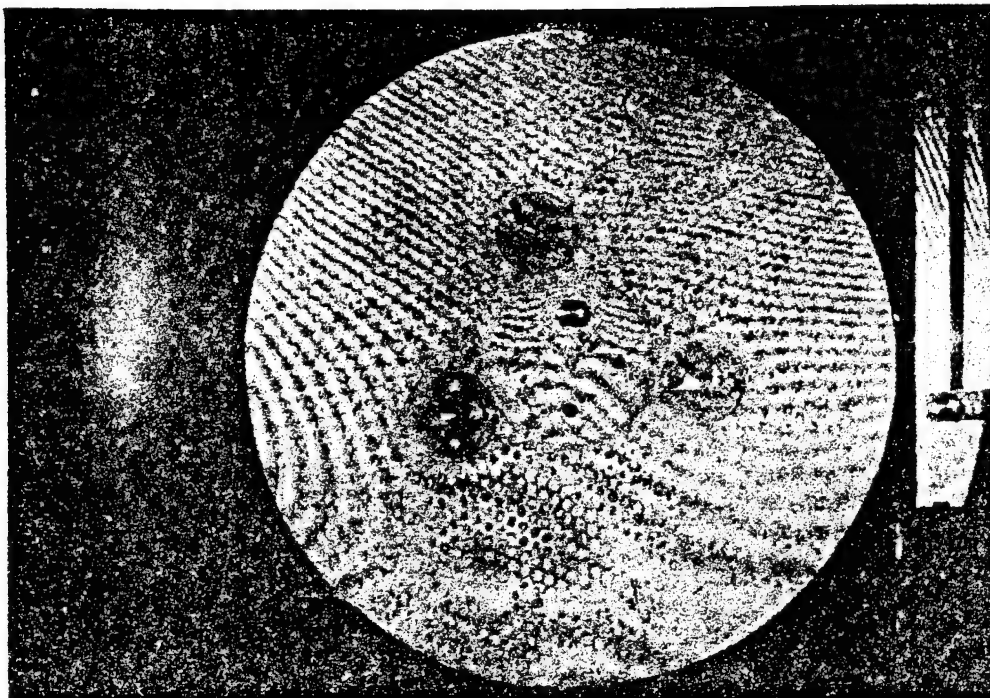
Figure 28 An interferogram of a CFRP/Al honeycomb dish specimen and its superimposed holographic image. Four circular areas of perturbed fringe pattern can be seen and right of centre towards the lower edge of the dish, the fringe pattern caused by hole cut in the skin/core film adhesive is visible.

Note the visualisation of the honeycomb cells, and also the regular fringe pattern on the stand to the right of the dish. Closely spaced fringes around the central fixing bolt indicate an area of high strain. (Sections 3.6 and 5.1.7.)
